# Manhole Inspection Summary

Manhole # S47CC\_022MH

Insp Date: **7/22/08 9:52 AM**

**Location** Address: **Port**

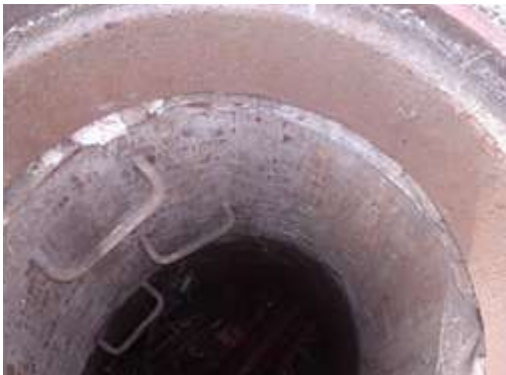
Defect 2

deterioration

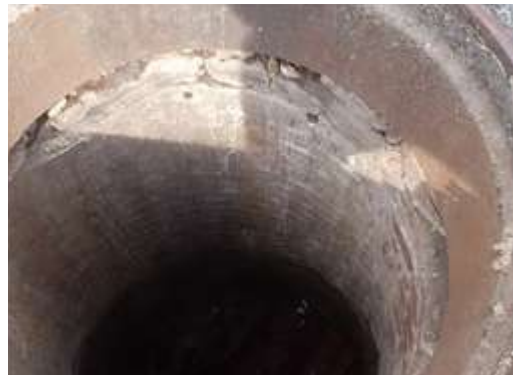
Defect 1

Condition: ☐ Sound ☐ Cracked ☐ Root Intrusion ☒ **Loose Brick** ☐ Deteriorated

Infiltration: ☐ None ☐ Joint ☐ Cracks ☒ **Mortar** ☐ Roots ☐ Wall

loose brick

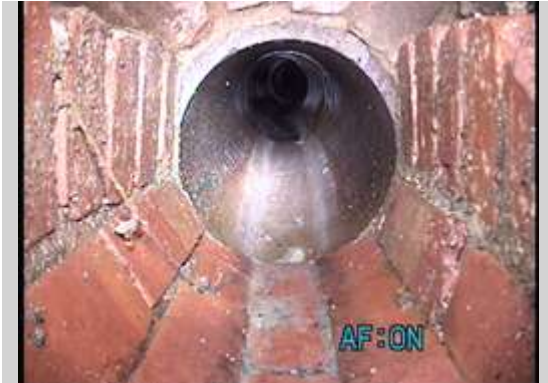
12 O'Clock Outflow

8 in. Circular Gravity Sewer  
Pipe Out @ 12 O'Clock

Pipe Height: **8.4** (in.) Rod and Bar (Angled)  
Pipe Material: **Clay** ☐ Pipe Lined  
Invert Depth: **9.70** (ft.) Flow Characteristics: **None**  
Deposits: ☒ None ☐ Mud ☐ Sludge ☐ Debris ☐ Grease  
Silt Depth: (in.) Deposits Extent:  
Infiltration: **None** Pipe Seal Cond: **Sound**

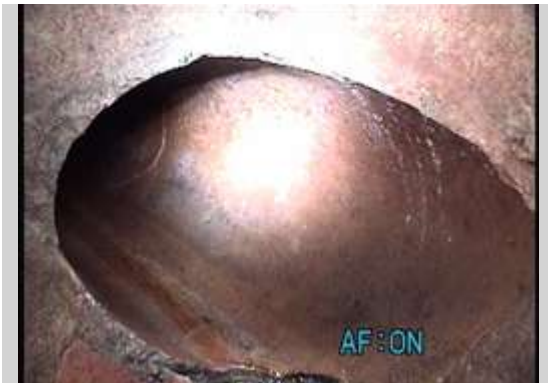
3 O'Clock Inflow

8 in. Circular Gravity Sewer  
Pipe In @ 5 O'Clock

Pipe Height: **8.4** (in.) Rod and Bar (Angled)  
Pipe Material: **Clay** ☐ Pipe Lined  
Invert Depth: **9.00** (ft.) Flow Characteristics: **None**  
Deposits: ☒ None ☐ Mud ☐ Sludge ☐ Debris ☐ Grease  
Silt Depth: (in.) Deposits Extent:  
Infiltration: **None** Pipe Seal Cond: **Sound**
